MISCELLANEOUS PAPER NO. 4-850

# EVALUATION OF GUIDE RAIL IN CONJUNCTION WITH KAISER AND HARVEY LANDING MAT (AM2)

October 1966

U. S. Army Engineer Waterways Experiment Station  
CORPS OF ENGINEERS  
Vicksburg, Mississippi

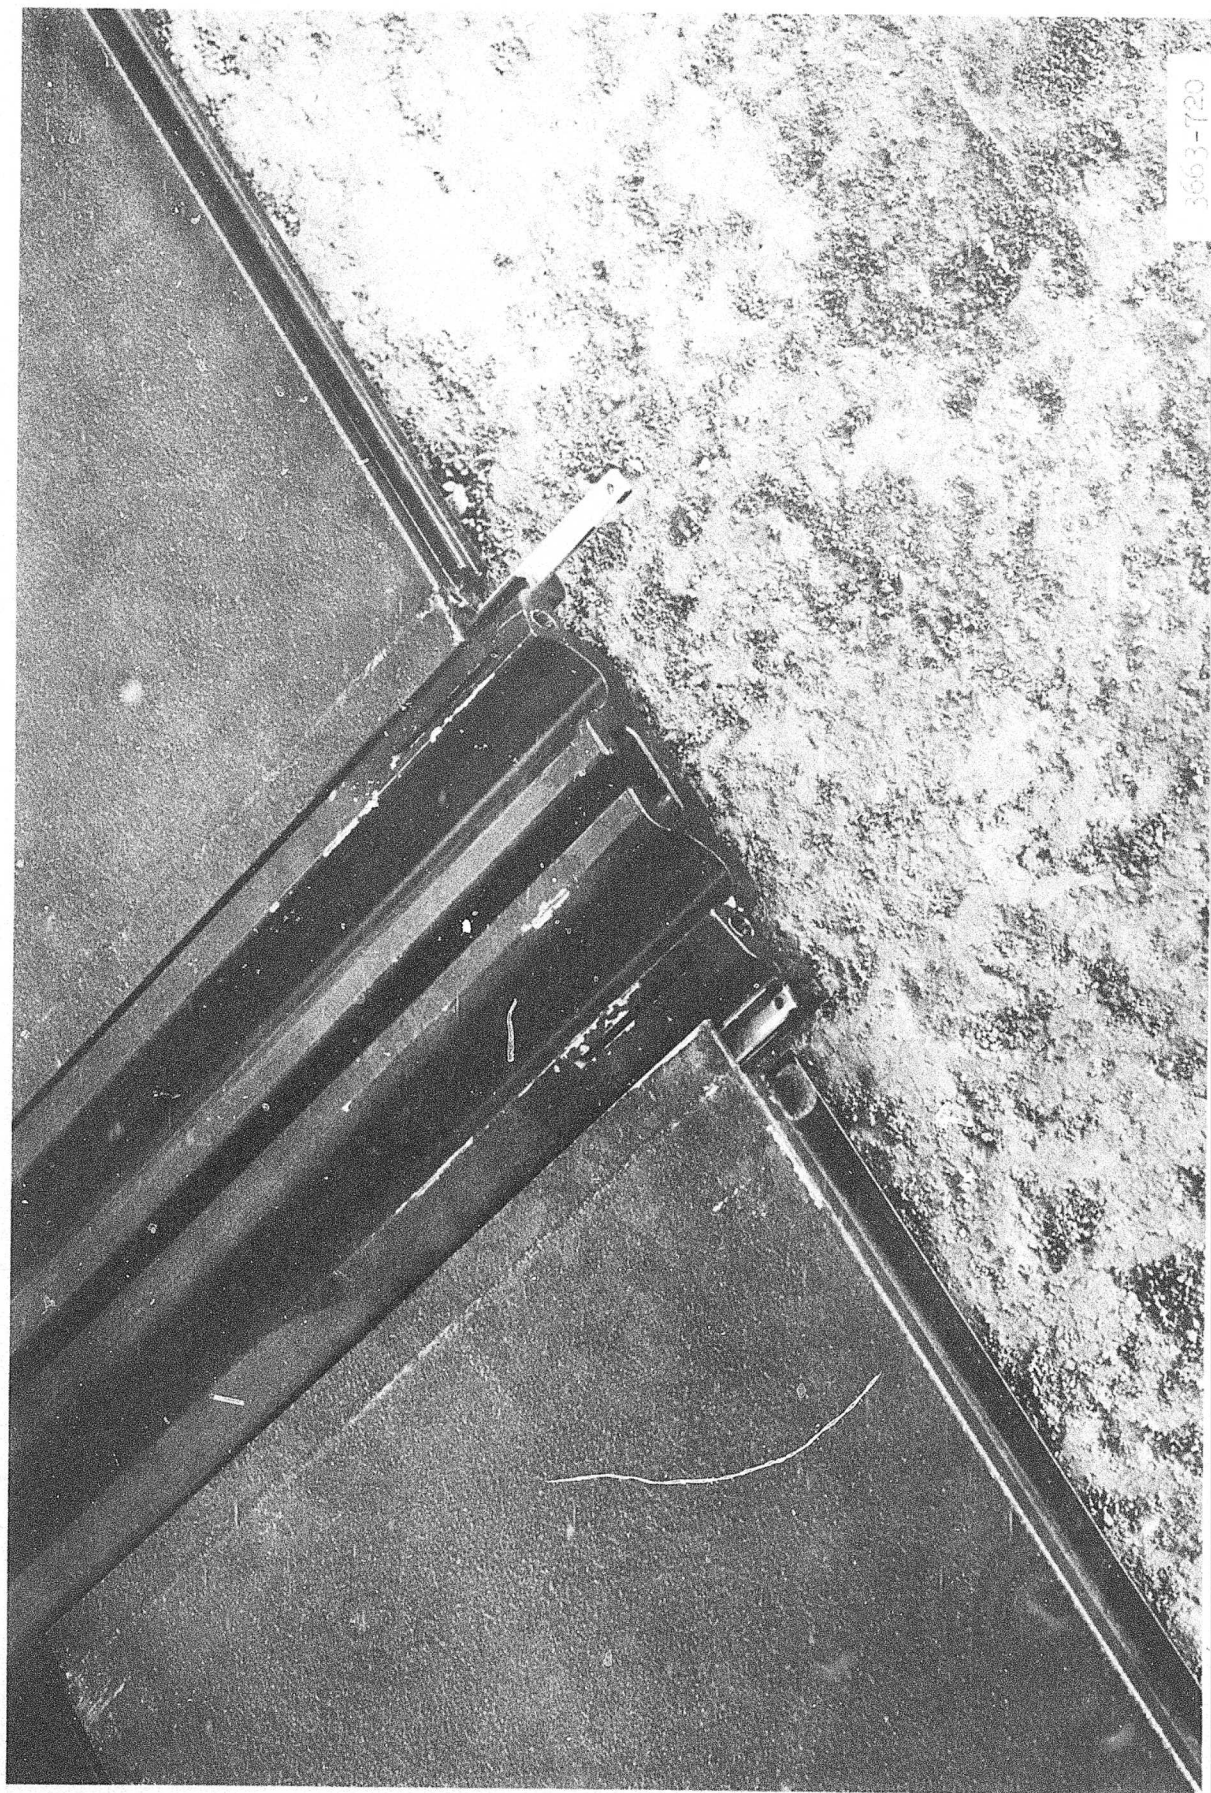
14. The AM2 was laid on both sides of the guide rail (fig. 5). Fifteen runs of mat were used in surfacing item 1, each run consisting of two whole mat planks, one on each side of the guide rail. A view of AM2 planks in place on both sides of the guide rail with locking bars partially inserted is shown in photograph 1. For items 2, 3, and 4, a full mat plank was used for each run on the west side of the guide rail, while on

Photograph 1. AM2 planks in place on each side of guide rail

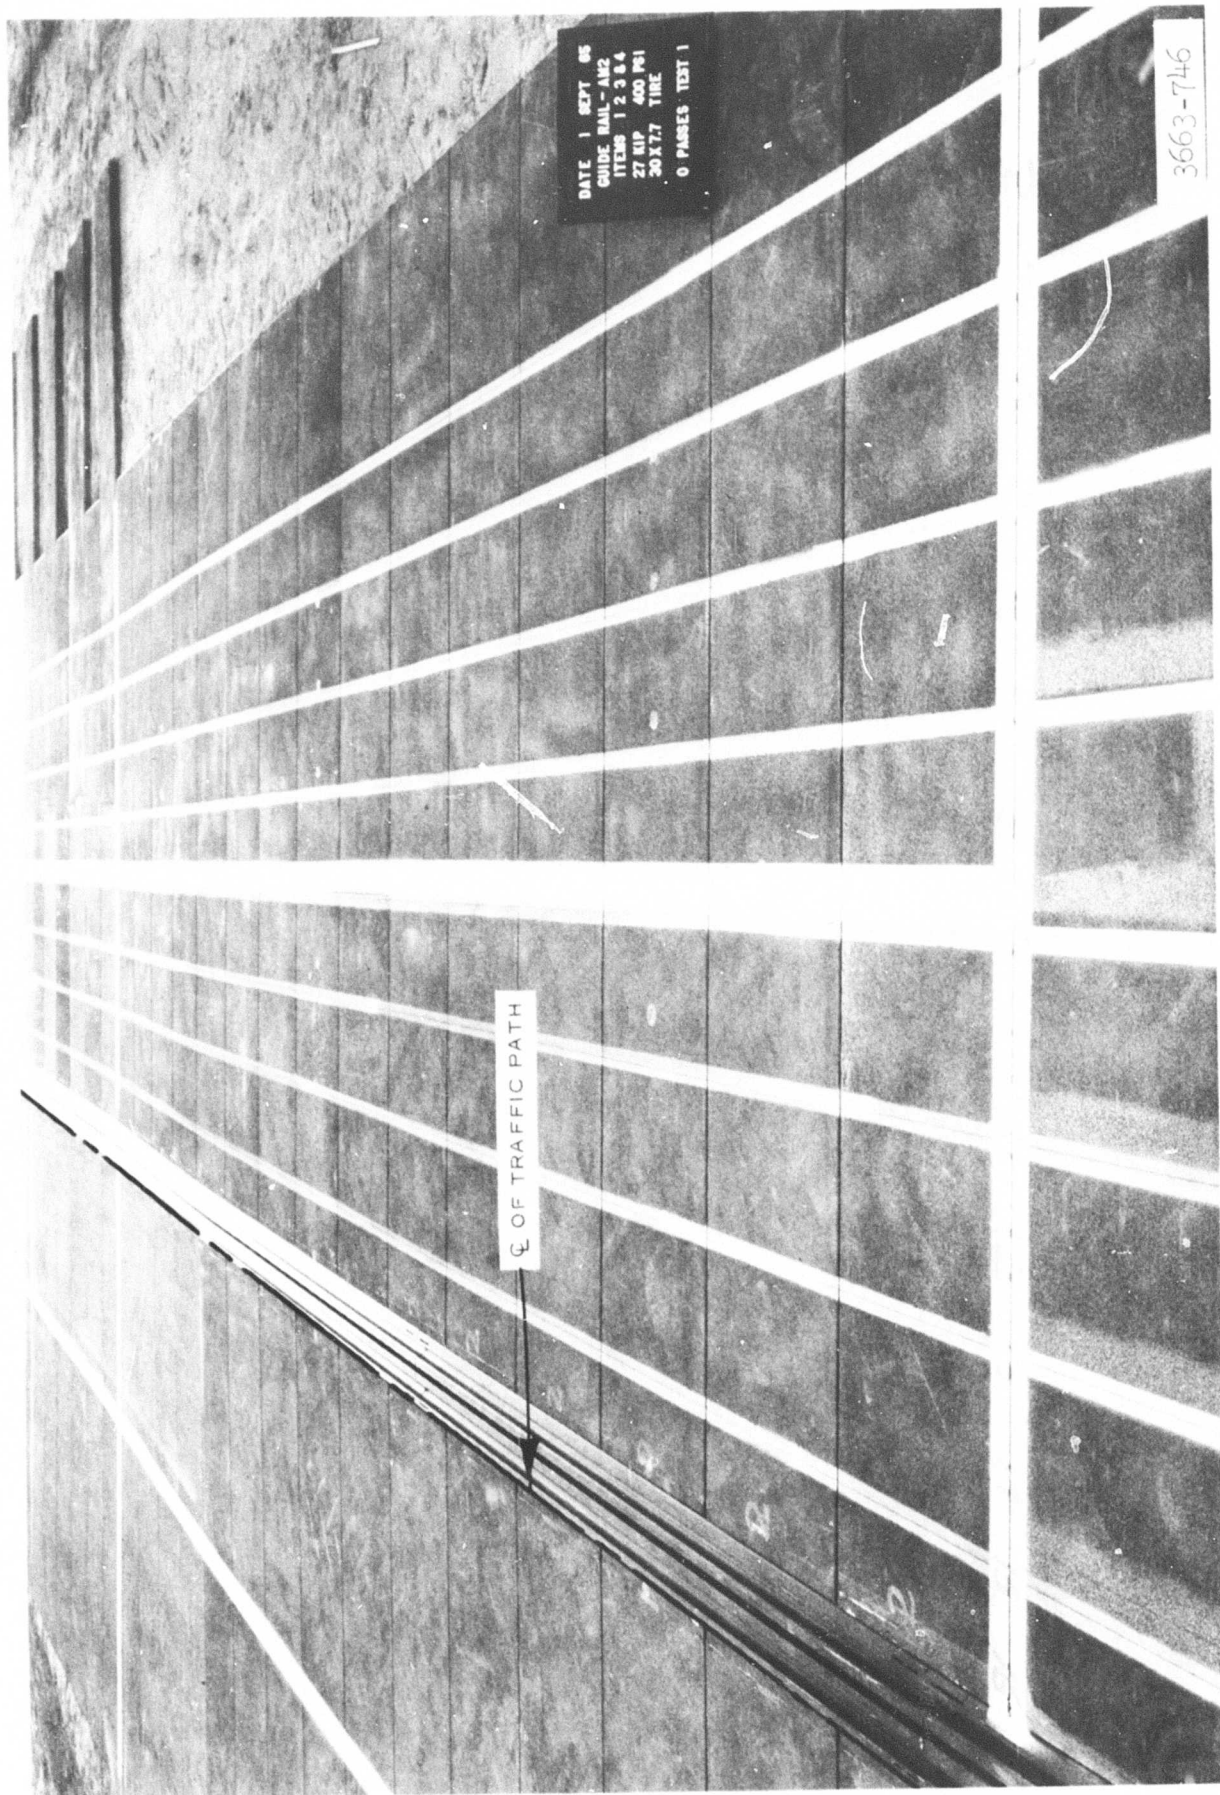
the east side of the guide rail, every other mat run contained a half plank that was placed next to the guide rail plus one whole plank that extended 6 ft beyond the east edge of the test section, as shown in photograph 2. This laying pattern was used to simulate the pattern that would normally be used on a runway, and resulted in a staggered joint pattern.

Photograph 2. Test section with guide rail

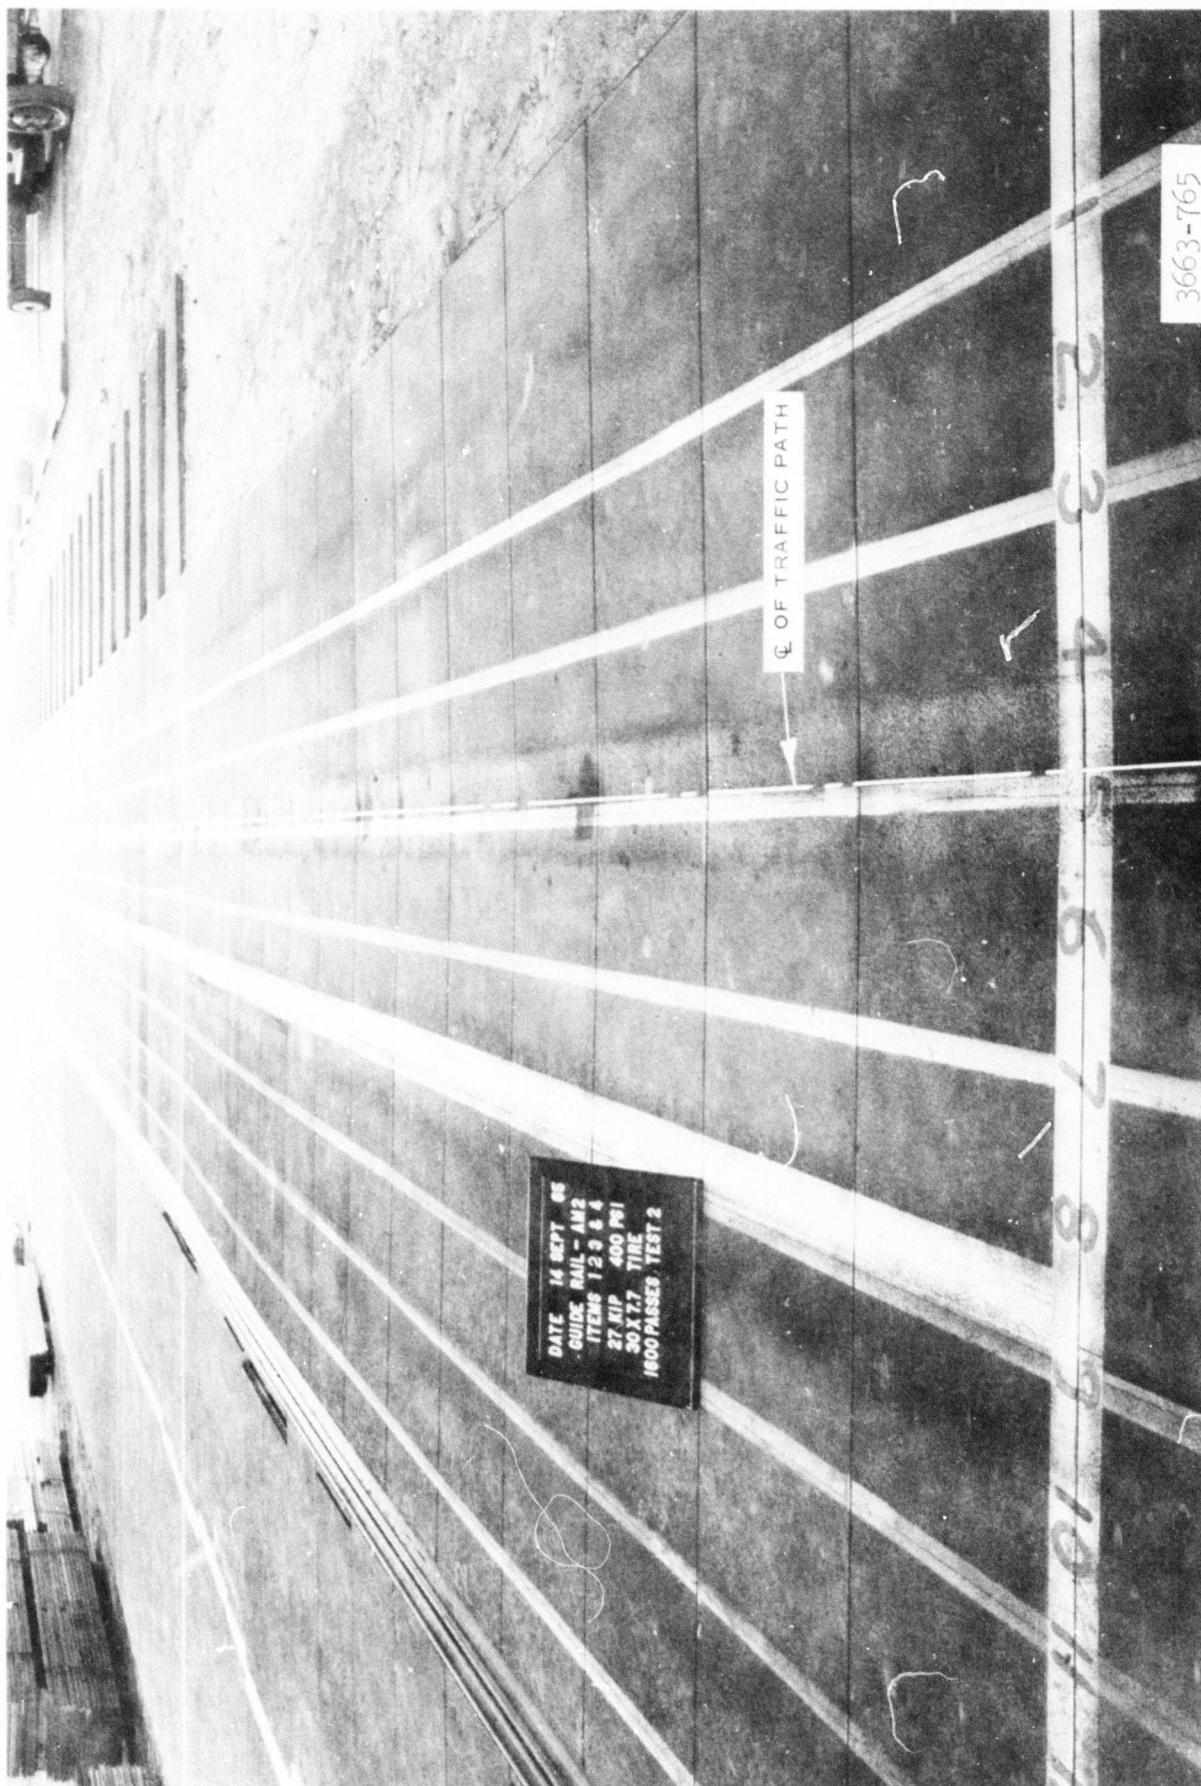
Photograph 12. Test lane 2 after 1600 passes of load wheel

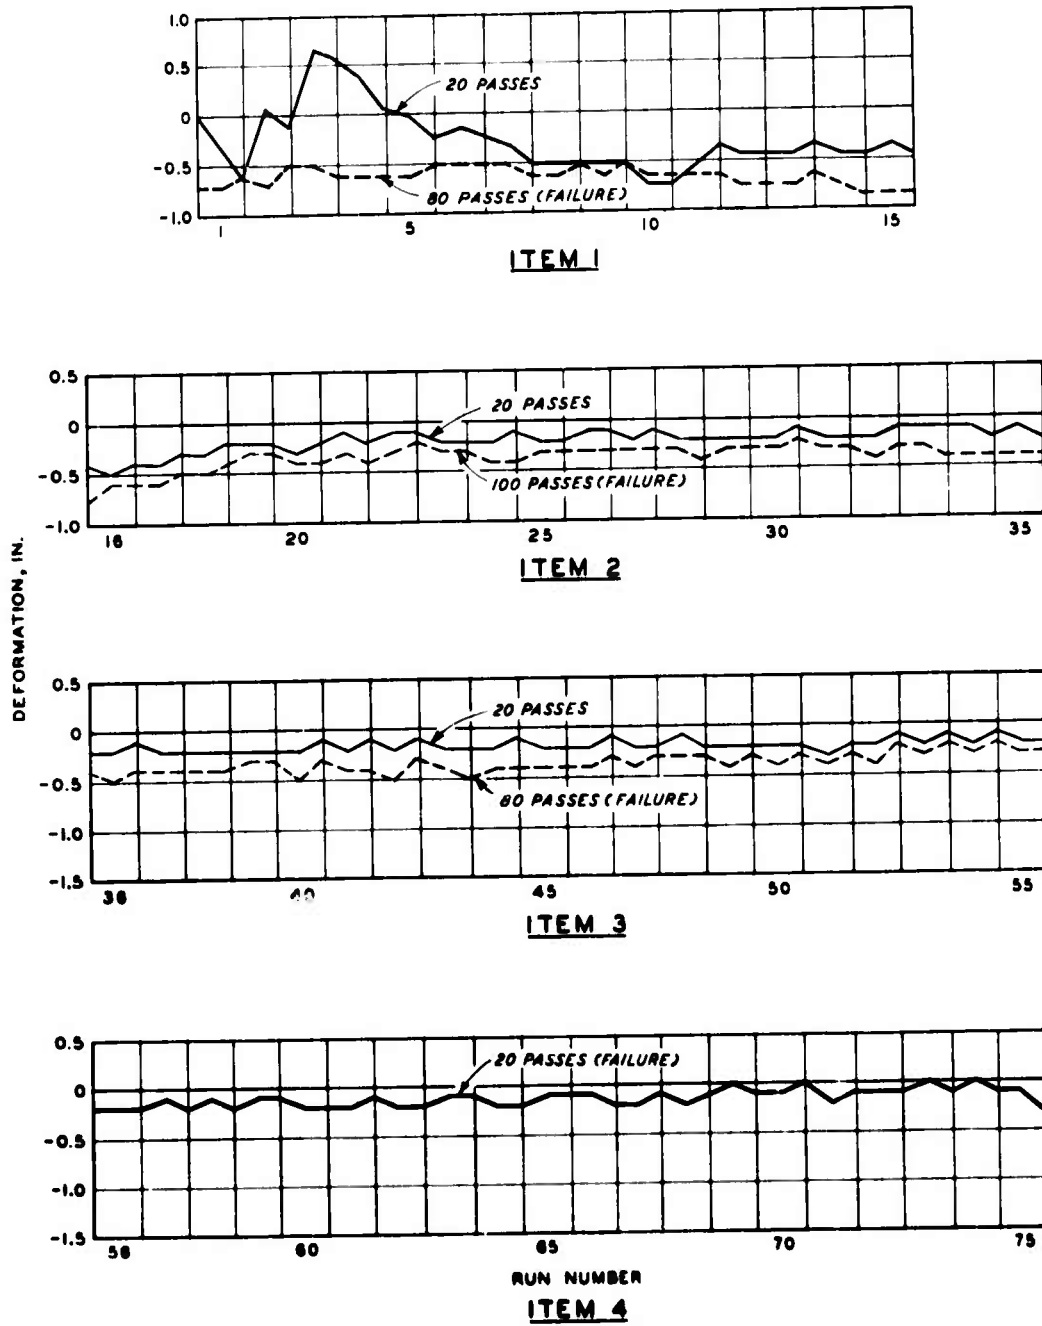
30. Permanent deformations. Profile plots showing permanent deformation of mat as determined from level readings taken prior to and at various traffic intervals in lane 1 are shown in plate 3. These data indicate that the greatest settlement occurred in item 1, which averaged about 0.6 in. at the end of 80 passes of traffic. The settlement in items 2, 3, and 4 was about the same at the end of 20 passes of traffic and averaged about 0.2 in. As can be noted, a slight increase in settlement occurred with an increase in traffic passes on items 2 and 3. Typical cross-section plots showing deformation across the traffic path in each test item are shown in plate 4.

PROFILES ALONG  
CENTER LINE OF  
TRAFFIC LANE  
TEST LANE I

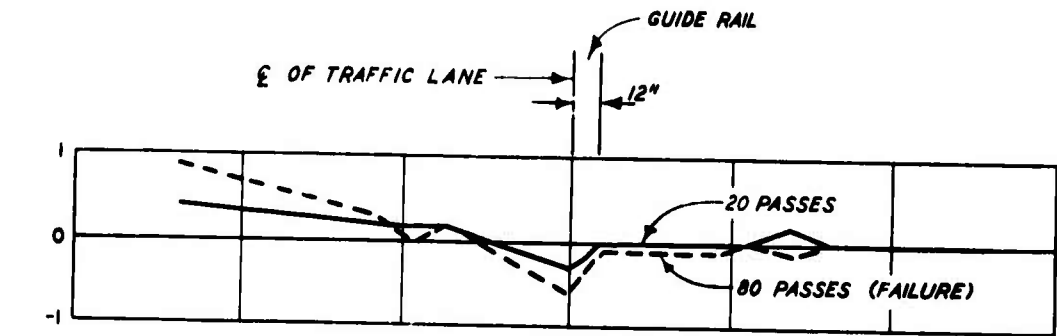
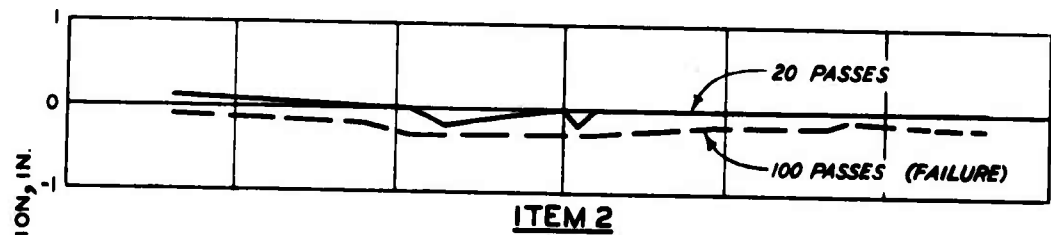
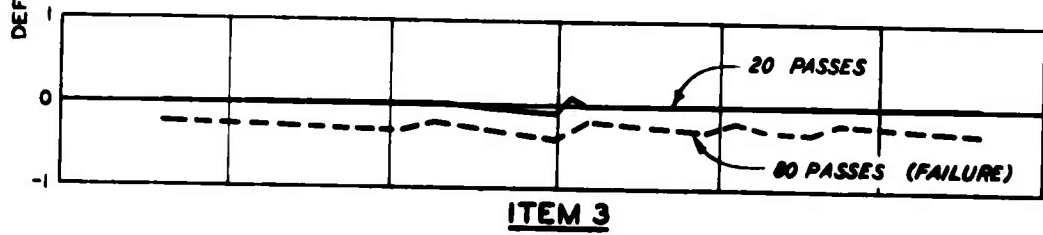
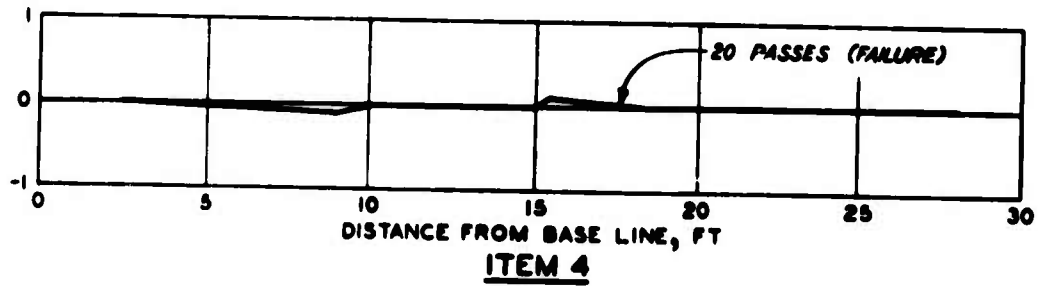
PERMANENT MAT DEFORMATION  
TEST LANE 1

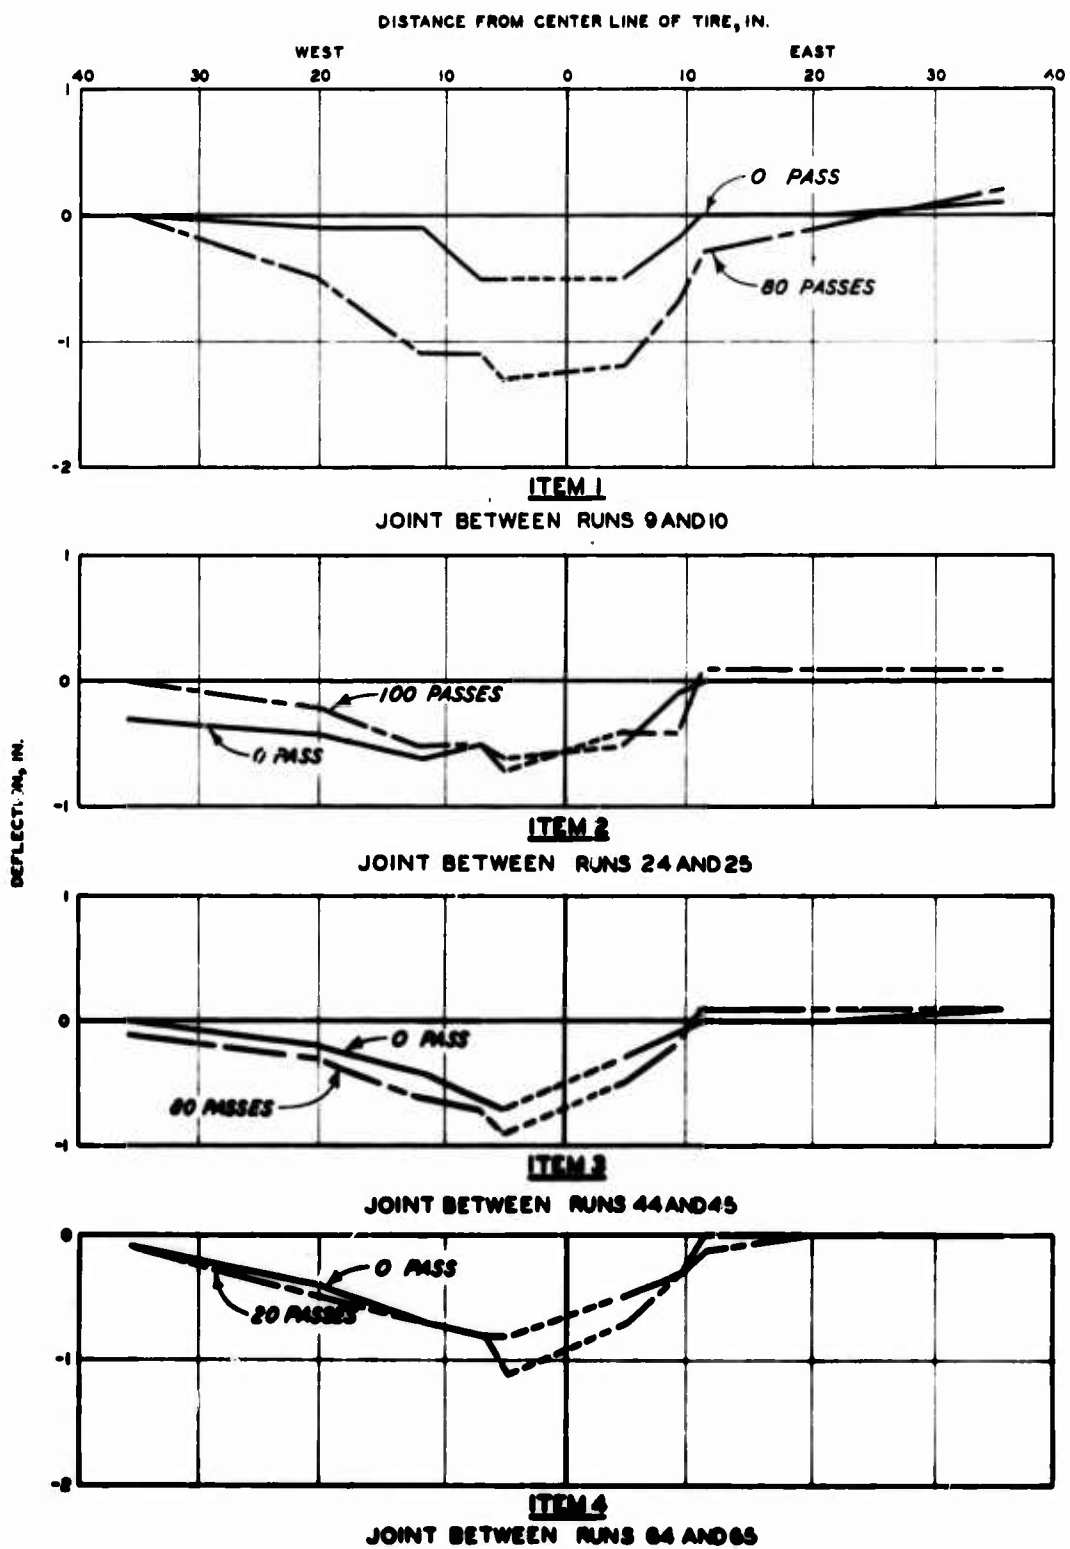
31. Elastic deflection. Deflections of the mat surface under load, determined from level readings, are shown in plate 5, which indicates the elastic deflection or rebound of the mat as the wheel load moved over the surface of the mat. Data are shown for conditions at the start of traffic and at the end of traffic. These data show that the greatest mat deflection occurred in item 1 and was about 1.3 in. at the end of 80 passes of traffic. Also, the difference between the deflection before and after traffic was greatest for item 1.

**ELASTIC DEFLECTION OF MAT  
TEST LANE 1**

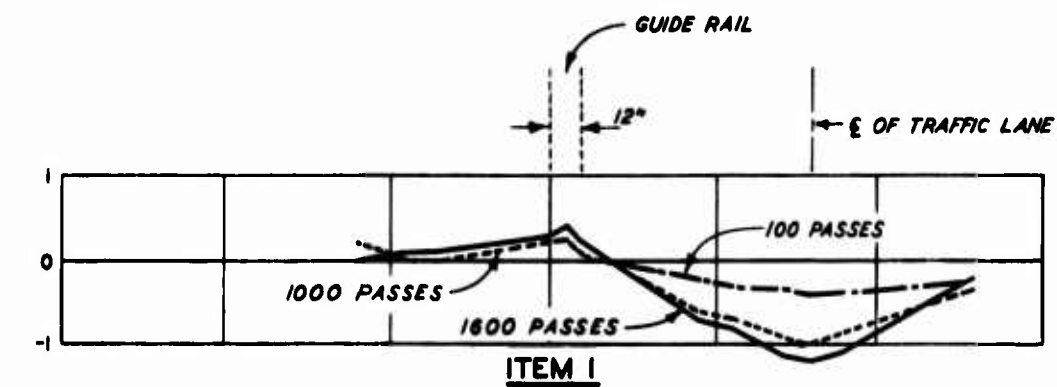
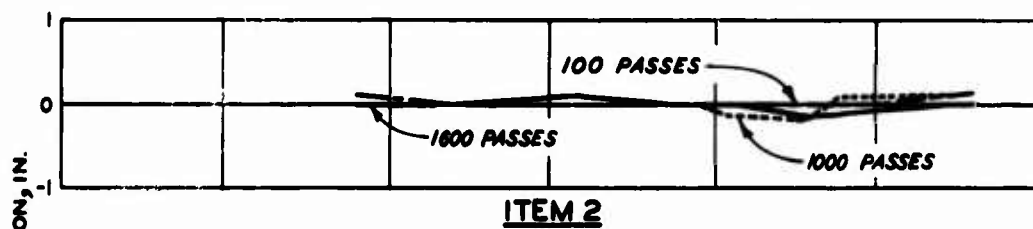
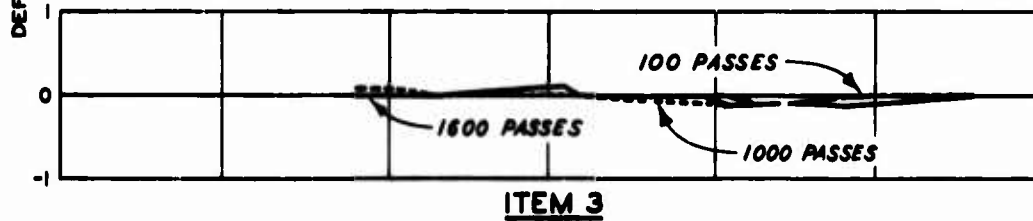
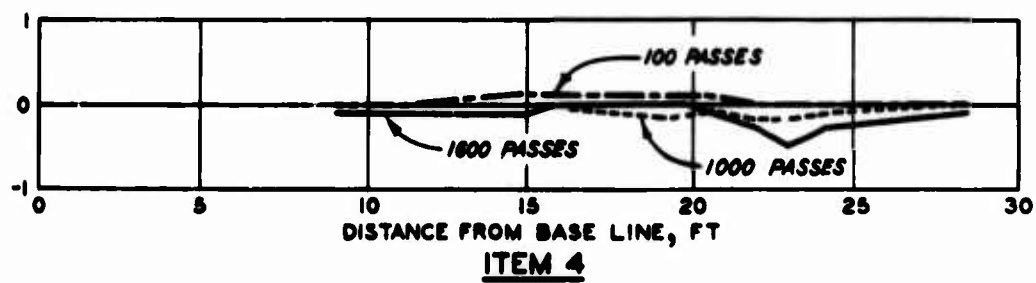
34. Permanent deformation. Profile plots showing permanent deformation of the mat along the center line of traffic lane 2 after various intervals of traffic are shown in plate 6. These data show that the greatest deformation developed in item 1 (sand subgrade) and the least deformation in item 2 (high-strength clay subgrade). Also, the deformation increased with an increase in load repetitions for all items, except item 2 where only minor deformations developed, with little or no change between 1000 and 1600 passes of the load wheel. Typical cross sections indicating the deformation across the traffic path after various intervals of traffic are shown in plate 7.

**PERMANENT MAT DEFORMATION  
TEST LANE 2**

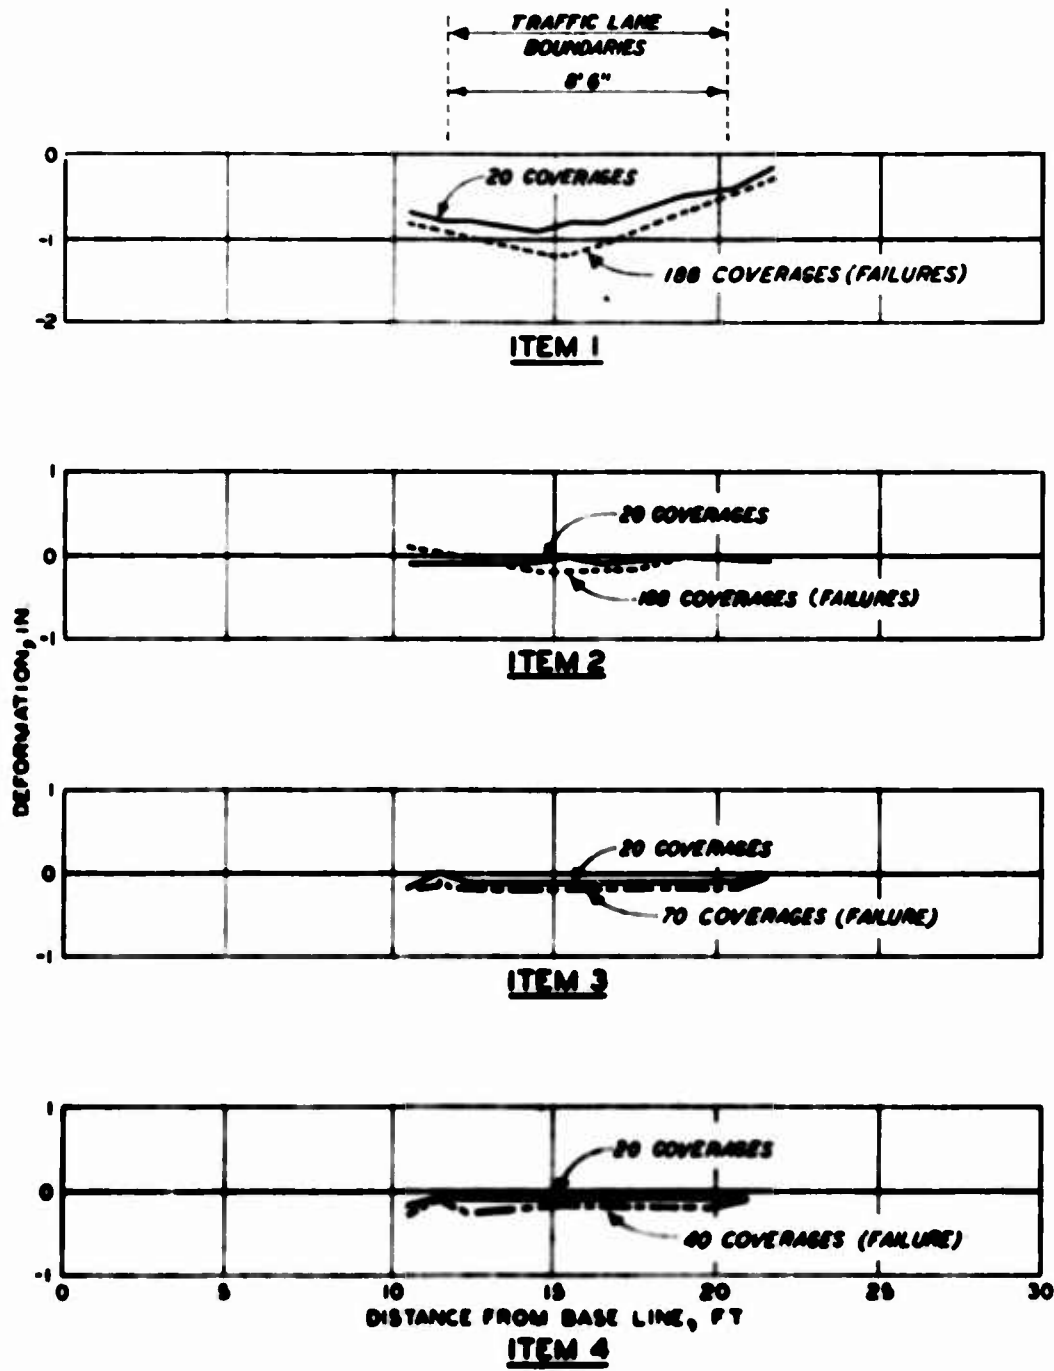
**PROFILES ALONG  
CENTER LINE OF  
TRAFFIC LANE  
TEST LANE 3**

NOTE WIDTH OF ONE RUN  
WAS 2 FT

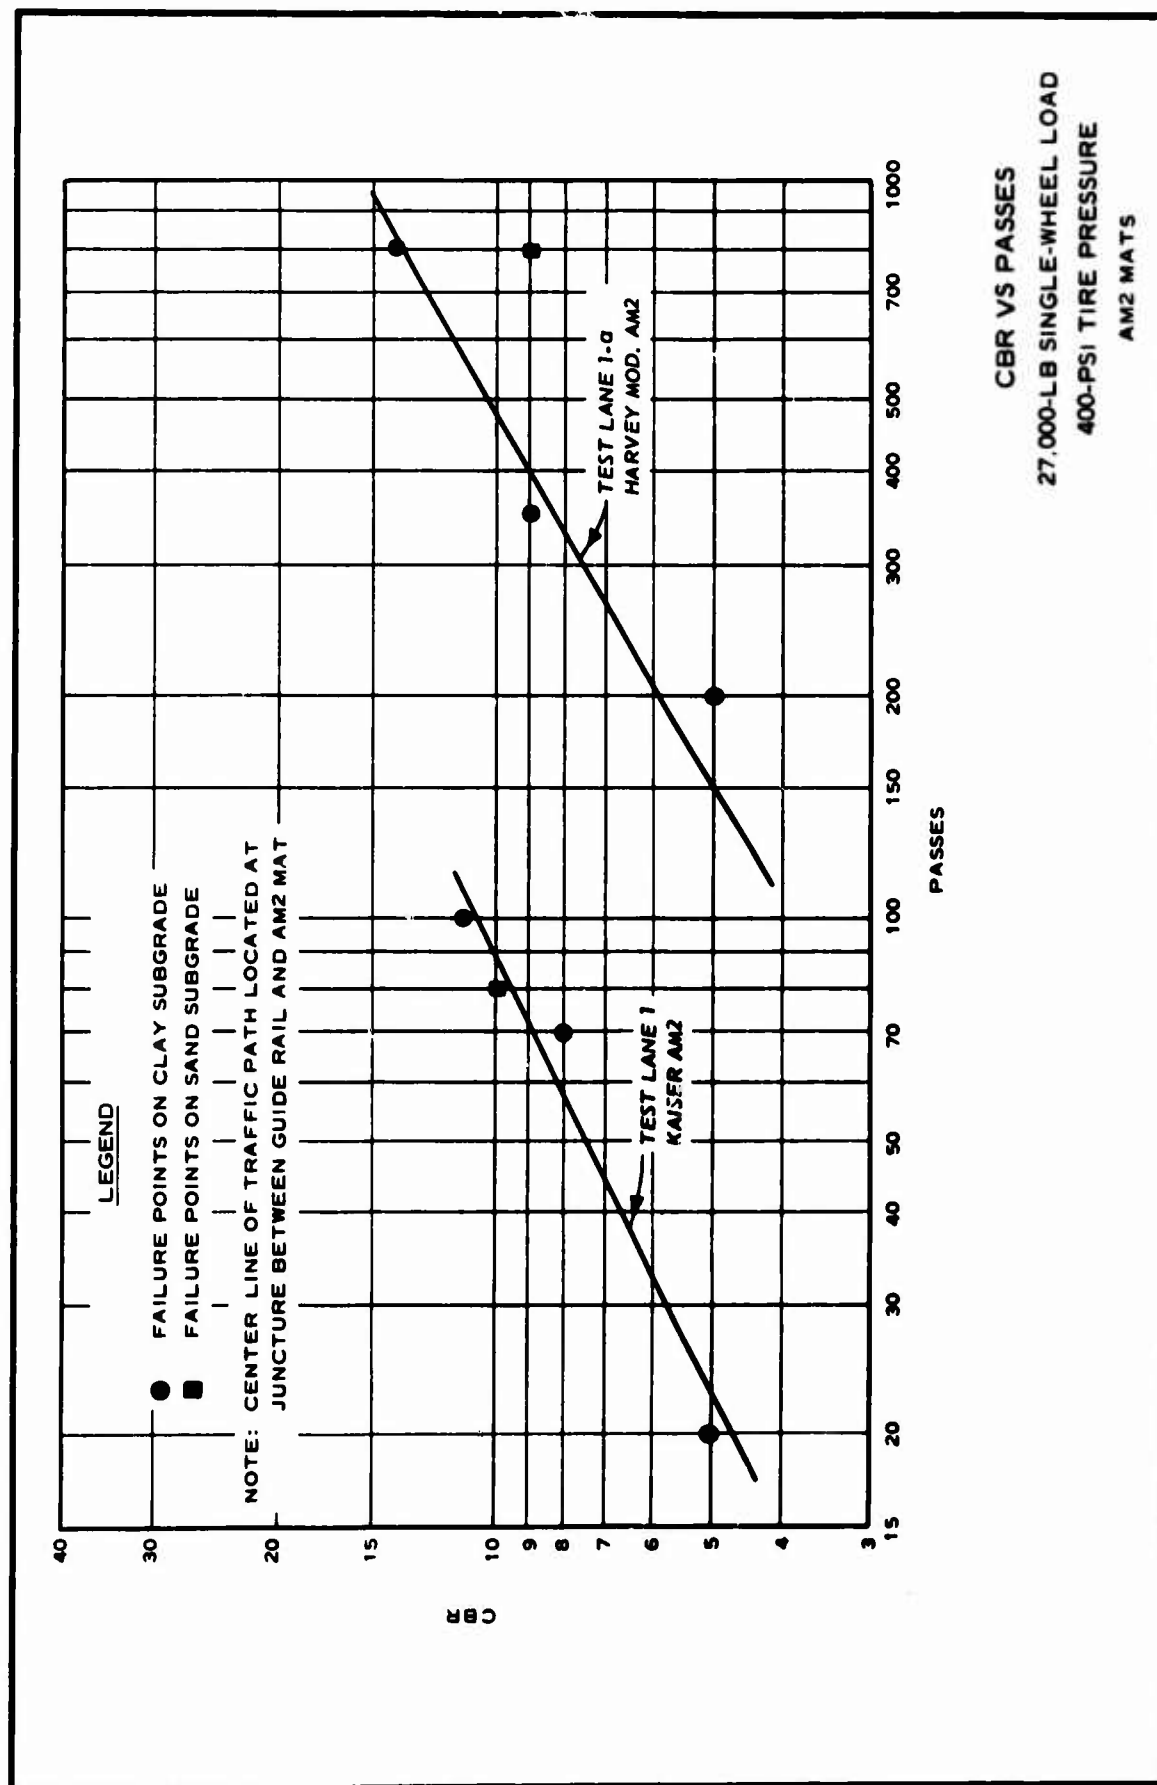
PLATE 14

52. Service life. A plot of CBR versus passes for both the Kaiser AM2 and the Harvey modified AM2 is shown in plate 14. The lines were drawn to best fit the failure points of the clay subgrade test items. The slope of the lines indicating the relation between CBR and passes is about the same for both mats. However, as can be noted, the service life of the Harvey modified AM2 was about five times greater than that of the Kaiser mat placed over subgrades of equal strength.

- c. Harvey modified AM2 used in conjunction with the guide rail on a subgrade having a CBR of 10 will sustain about 470 passes of a 27,000-lb single-wheel load and 400-psi tire inflation pressure when applied in a single path at the junction of the guide rail and the mat (see plate 14).
